Manhole Inspection Summary

Manhole # S35CC_017MH

Insp Date: **7/6/09 8:27 AM**

Location Address: **206 EAGER ST**

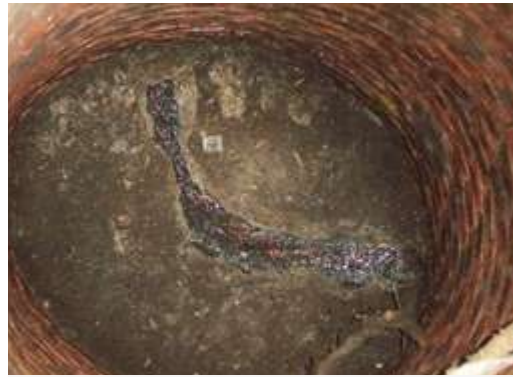
Top View

NEEDS CLEANING

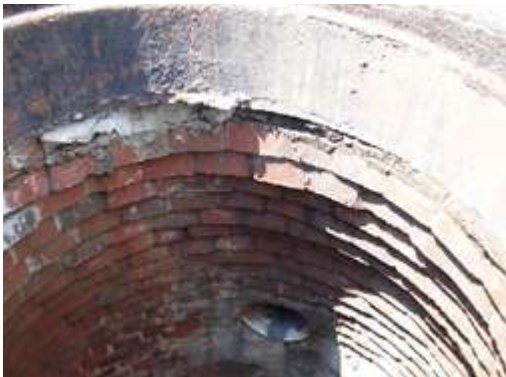
Overflow Pipe

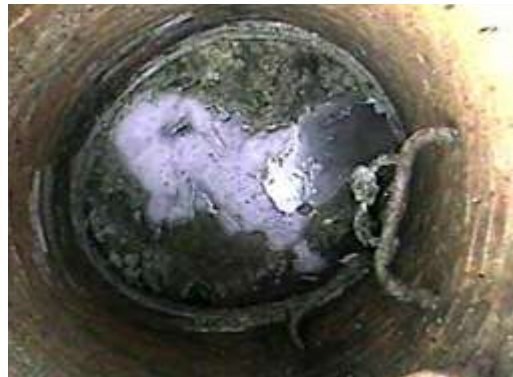
Defect 3

Steps Count: **4** Missing: **0** ☒ **Corroded**

Surcharge ☒ **Evidence Of Surcharge** Depth: **12** (ft.) ☒ **Active Surcharge Present**

STEPS CORRODED/EVIDENCE OF SURCHARGE/DEBRIS

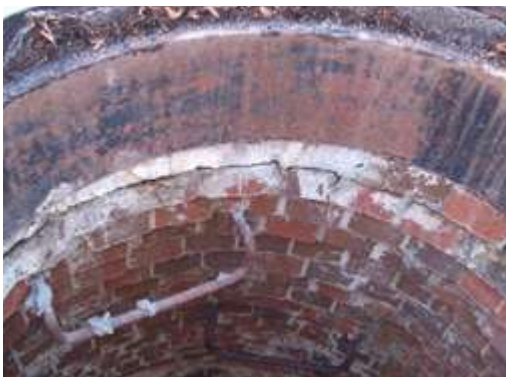
Defect 1

Condition: ☐ Sound ☒ **Cracked** ☐ Root Intrusion ☐ Loose Brick ☐ Deteriorated

CHIMNEY CRACKED

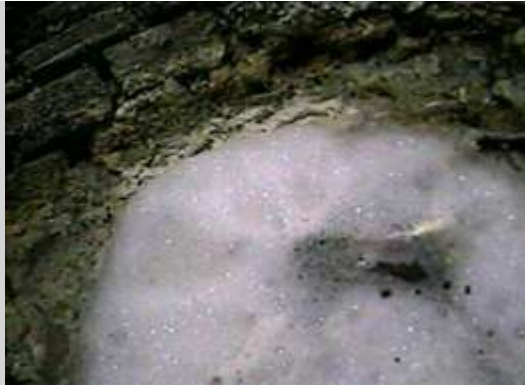
12 O'Clock Outflow

8 in. Circular Gravity Sewer
Pipe Out @ 12 O'Clock

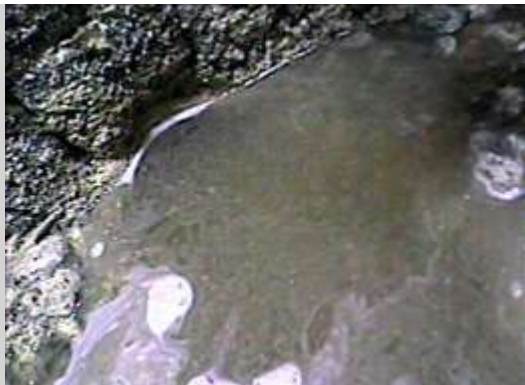
3 O'Clock Inflow

8 in. Circular Gravity Sewer
Pipe In @ 3 O'Clock
